# WROUGHT IRON *for* UNDERGROUND SERVICES

A TECHNICAL BULLETIN PREPARED BY THE ENGINEERING SERVICE DEPARTMENT

**A. M. BYERS COMPANY • PITTSBURGH, PA.**

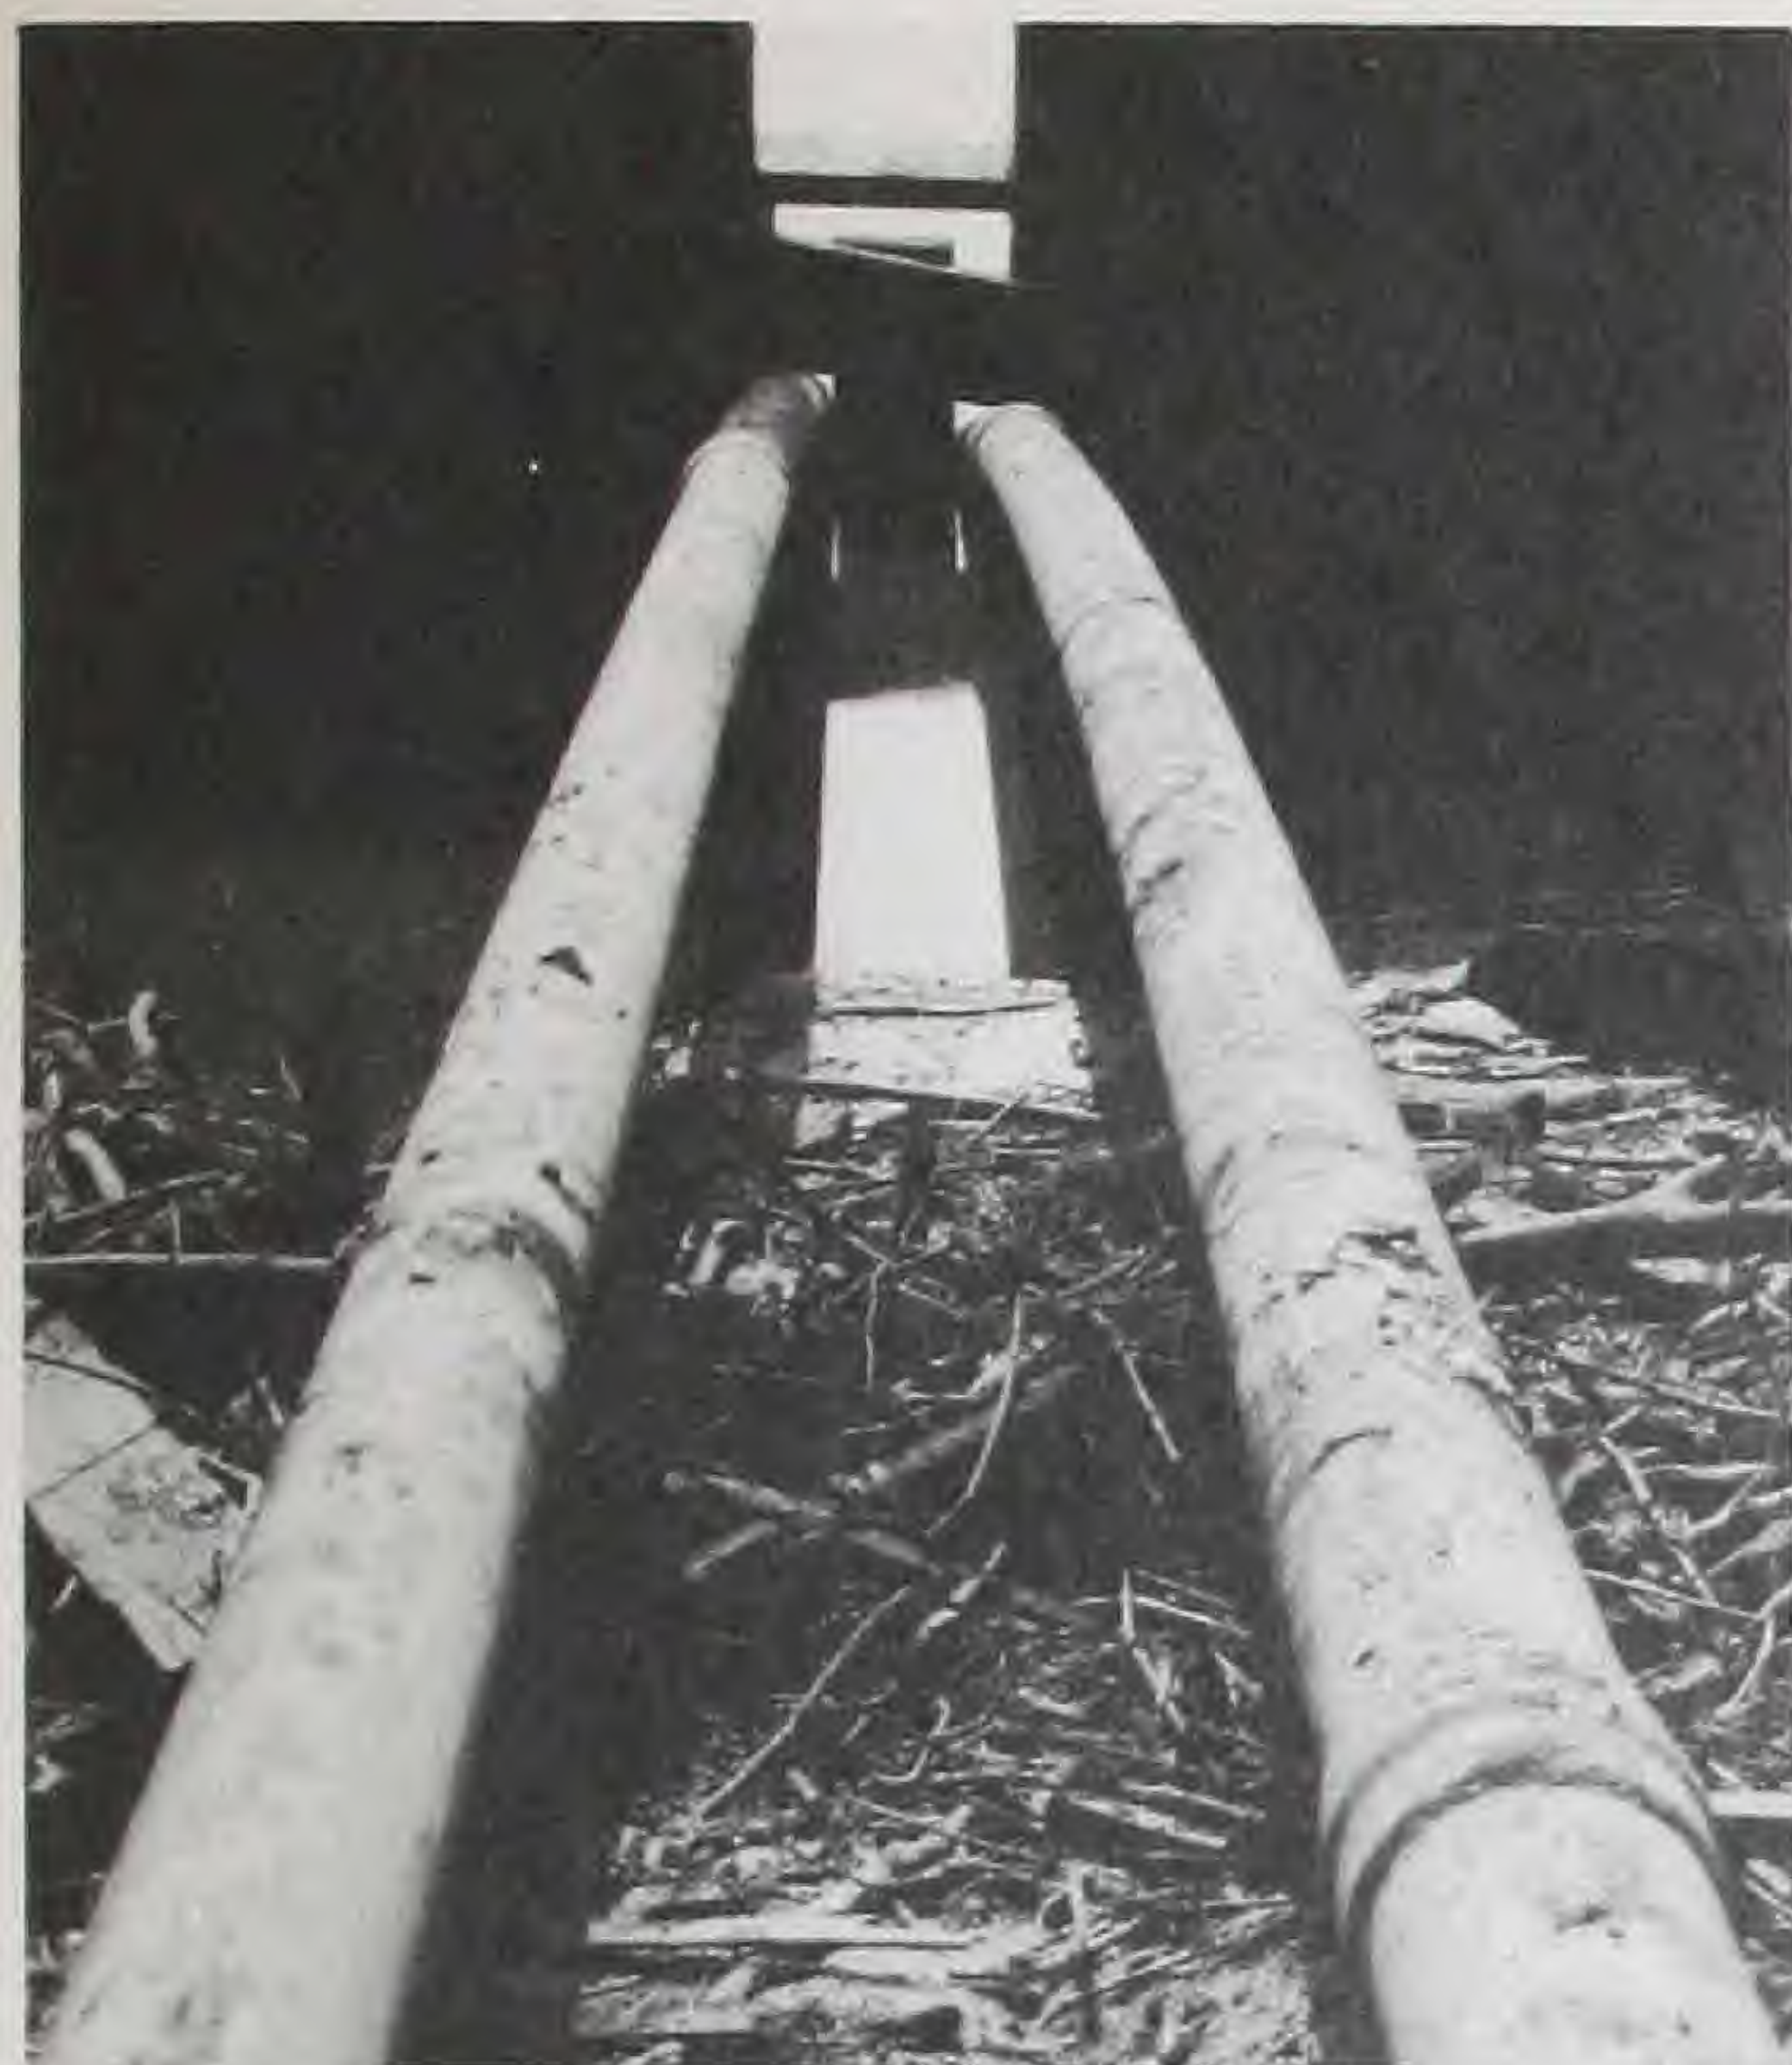
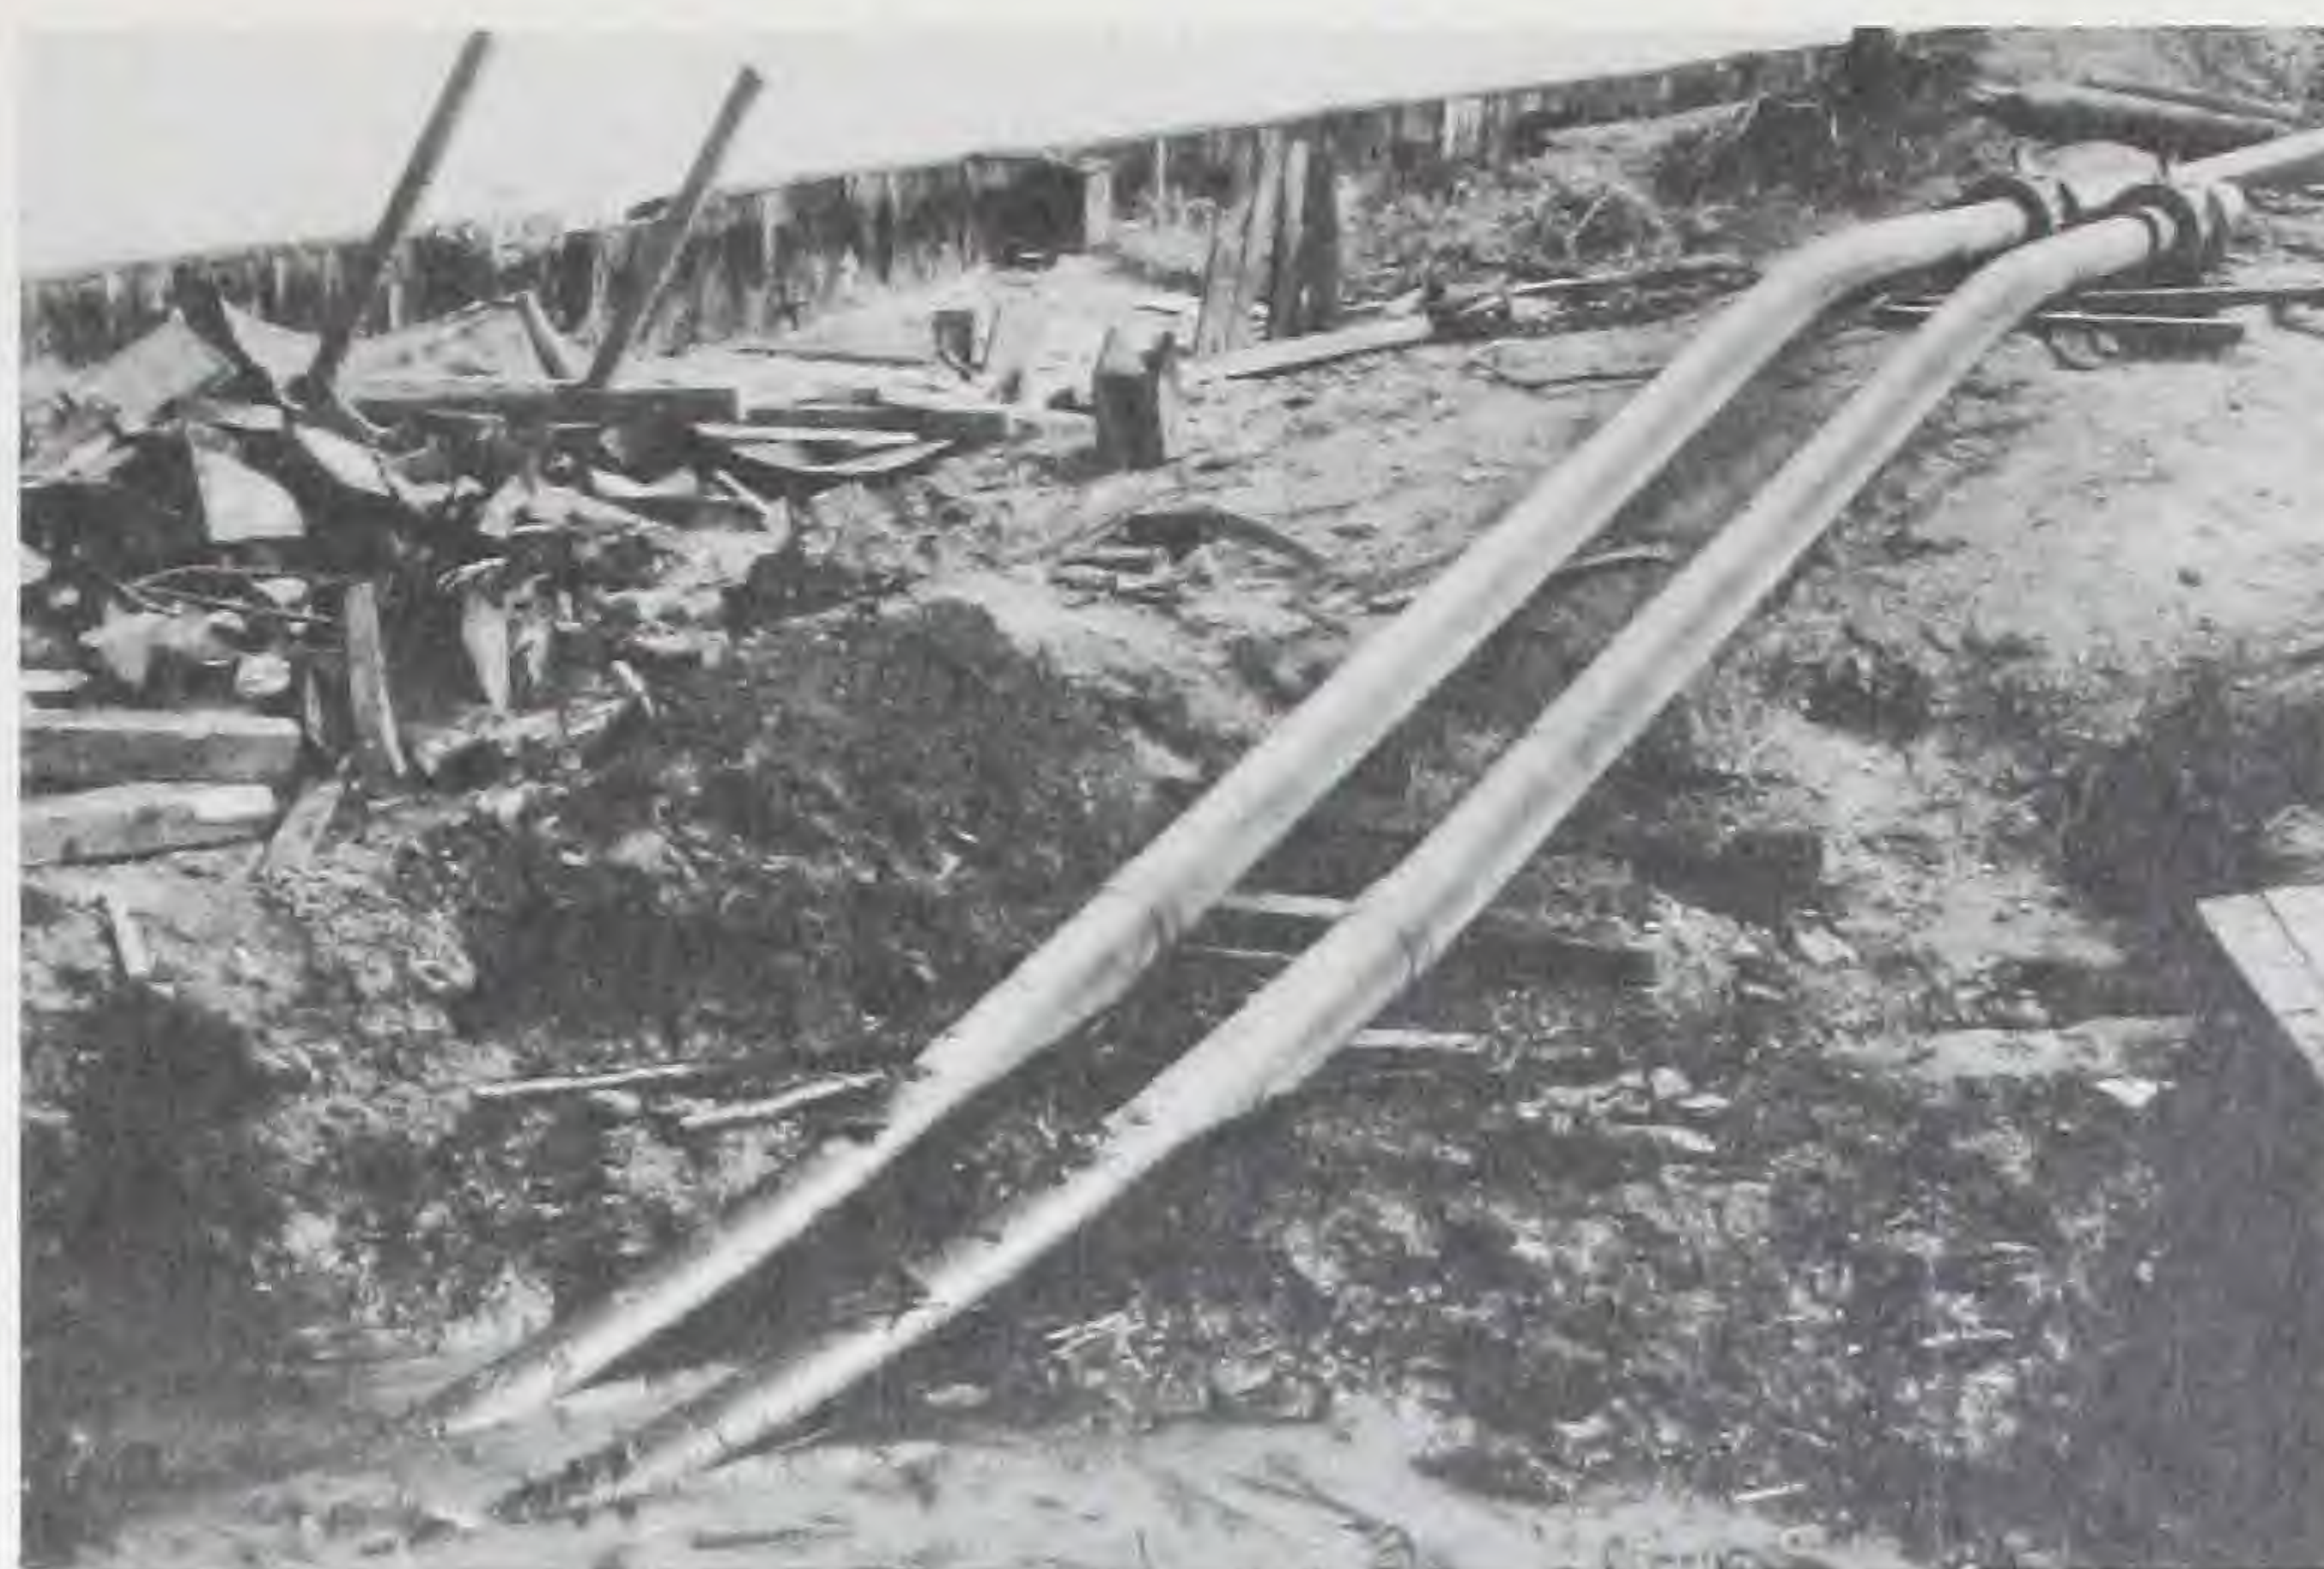
Figs. 36 and 37 show two lines of 6" Byers Wrought Iron pipe which carry crude oil under the Schuylkill River near Philadelphia to one of the large refineries. As is apparent from the photographs, the lines are of all-welded construction.

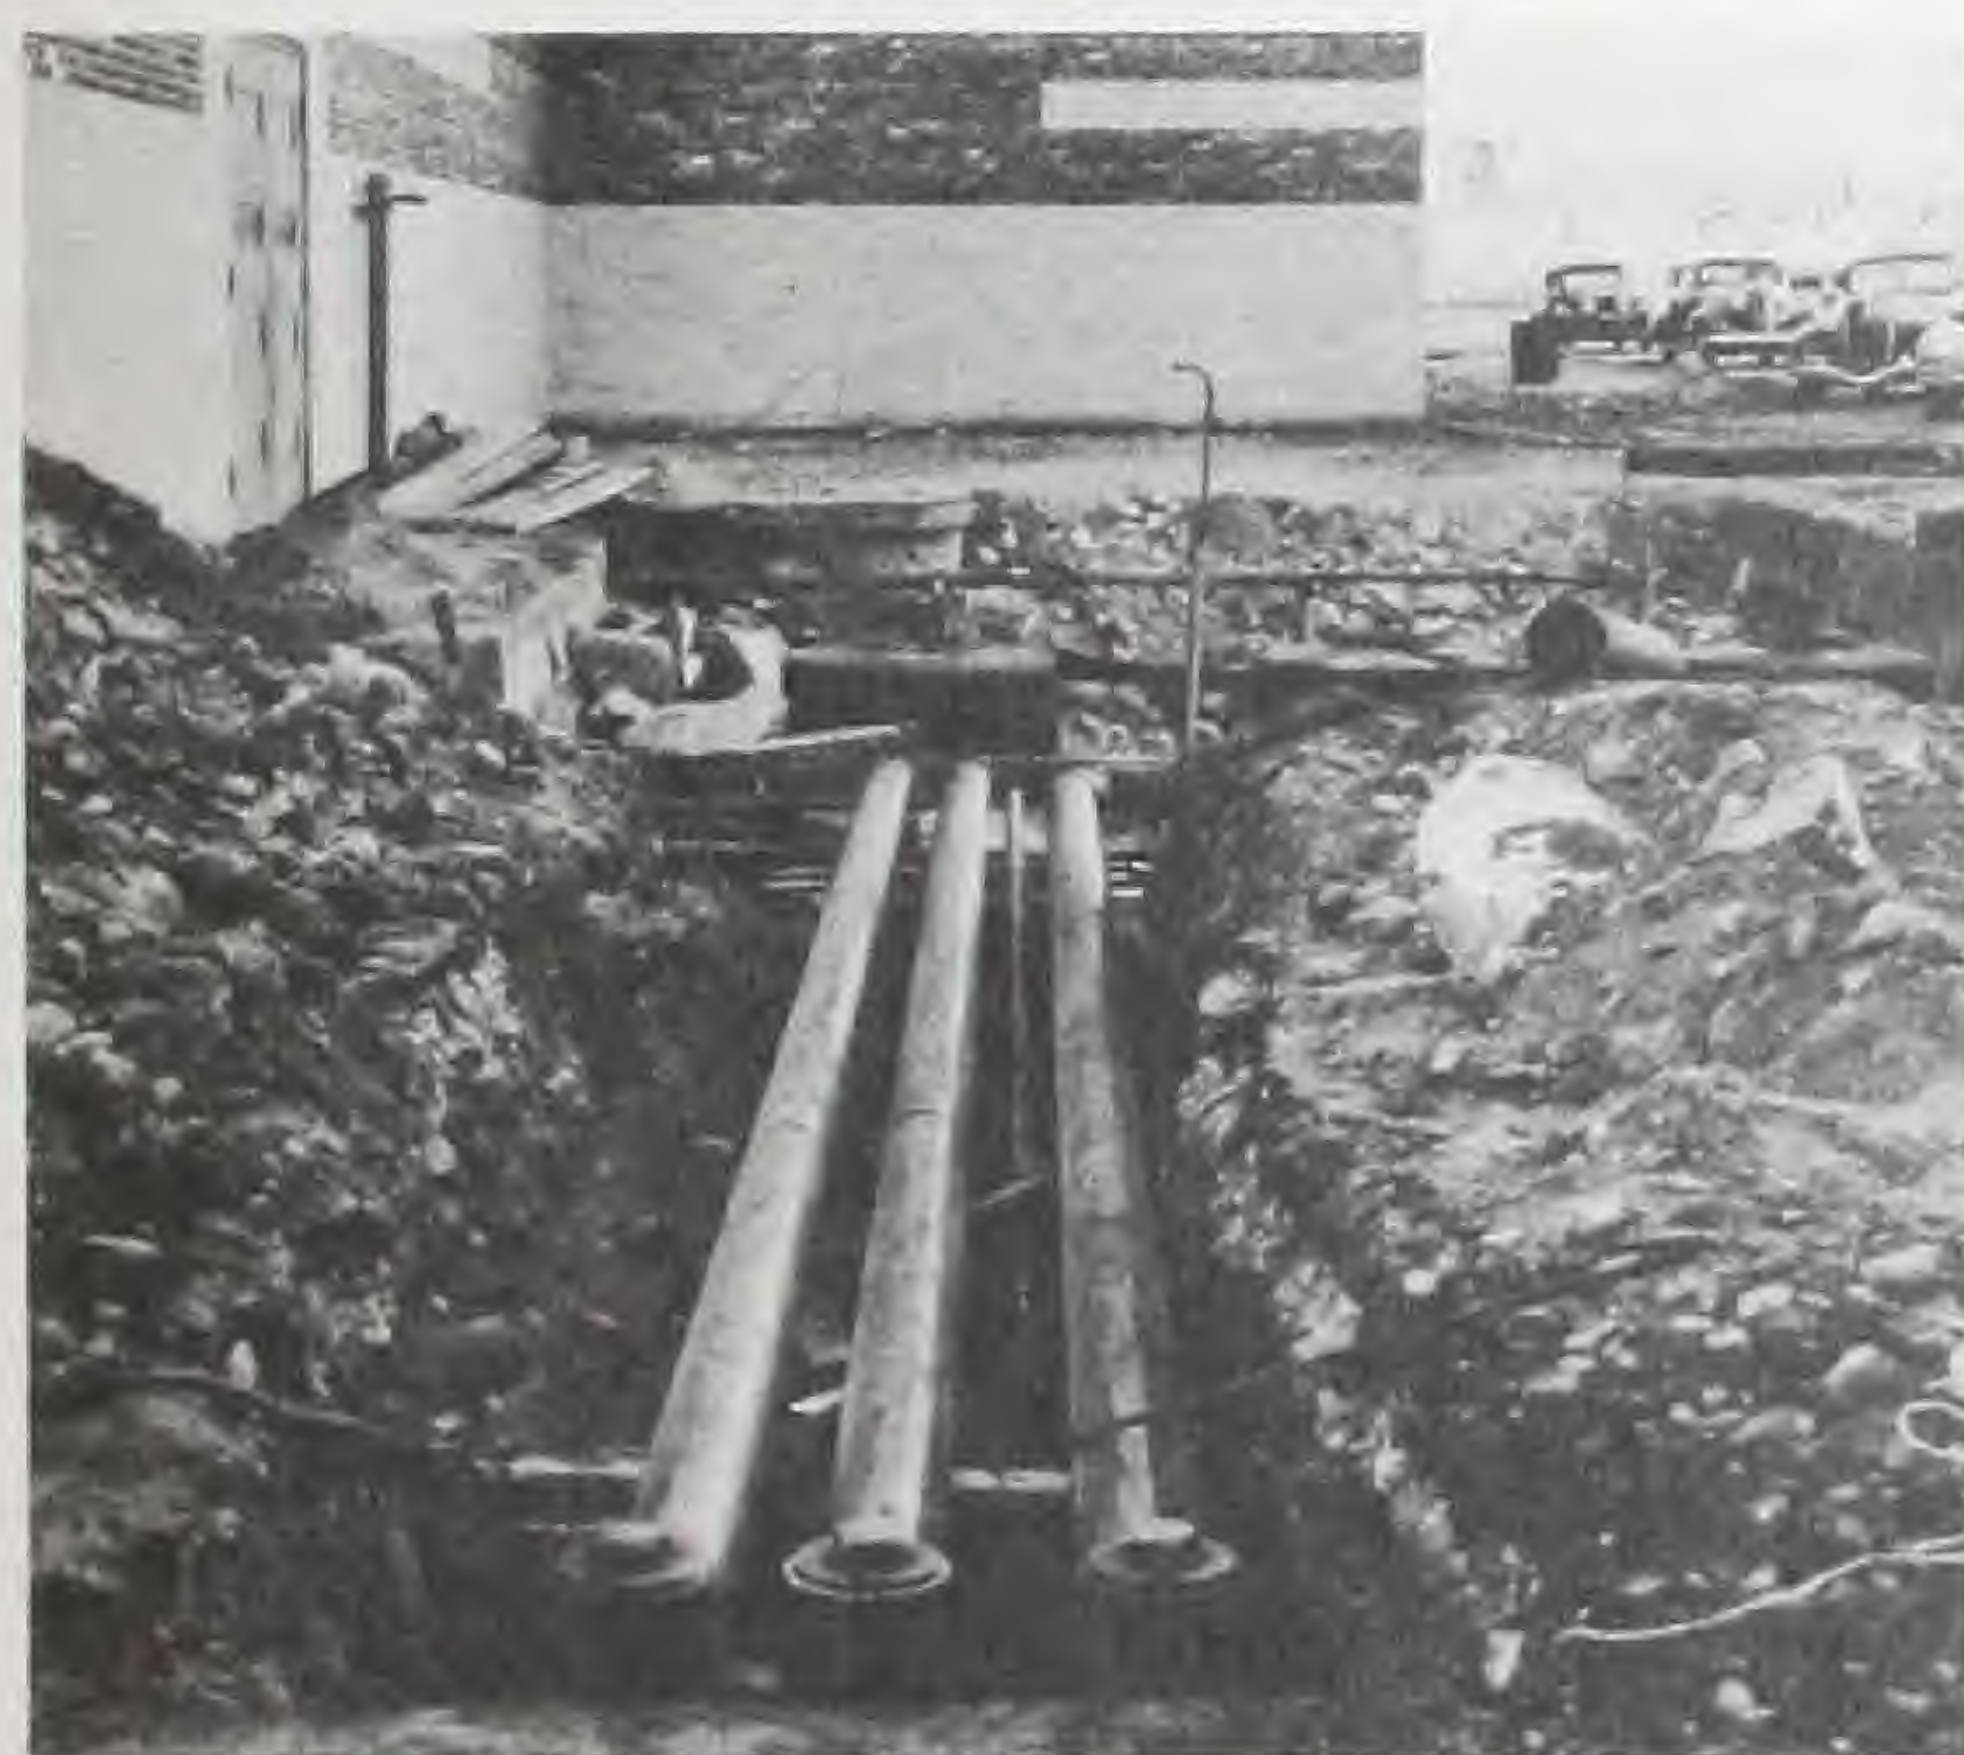
oil pressure lines from the underground storage tanks to smaller tanks inside the plant, and for air lines to these underground tanks. Other underground wrought iron services included water lines, steam supply lines, and steam returns. Fig. 38 shows 3 of the 6" oil lines being installed.

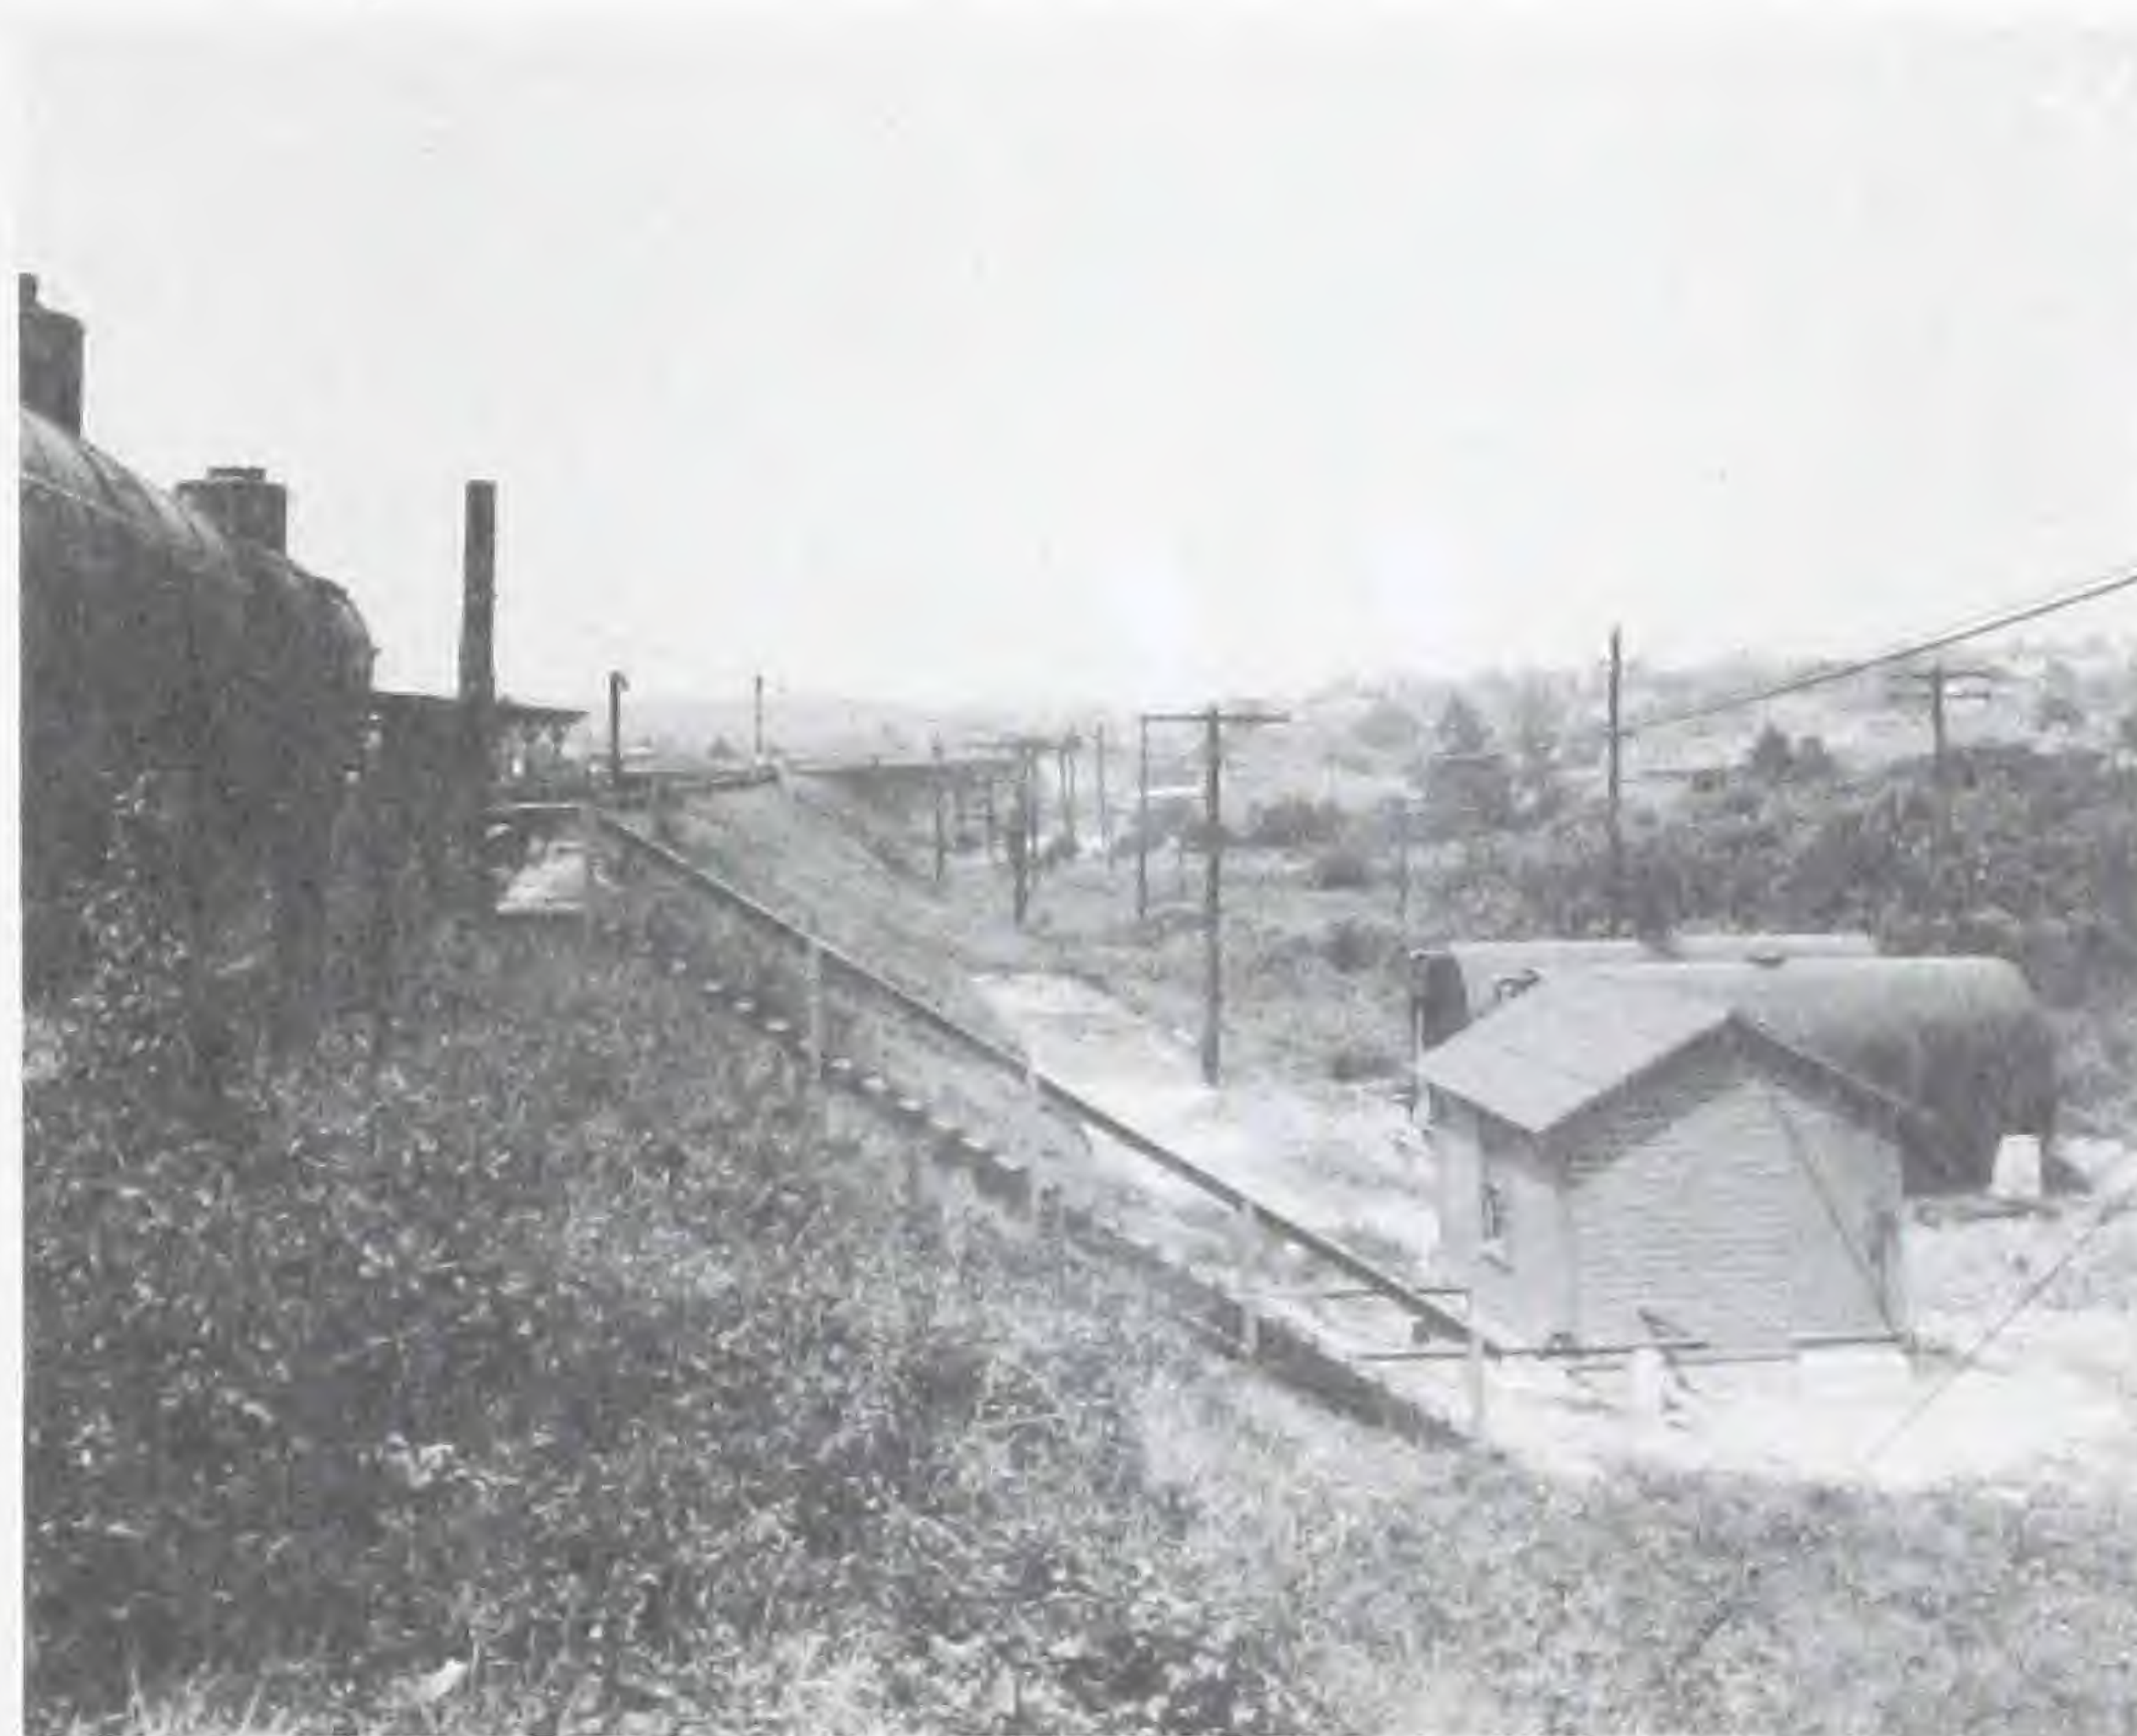
Fig. 39

With the increasing use of Diesel-powered trains, the need for fueling stations has arisen. One such station, at Danville, Virginia, is shown in Fig. 39. It is one of many similar stations on the Southern Railway Company's lines. All the fuel oil piping is 4" black wrought iron pipe.

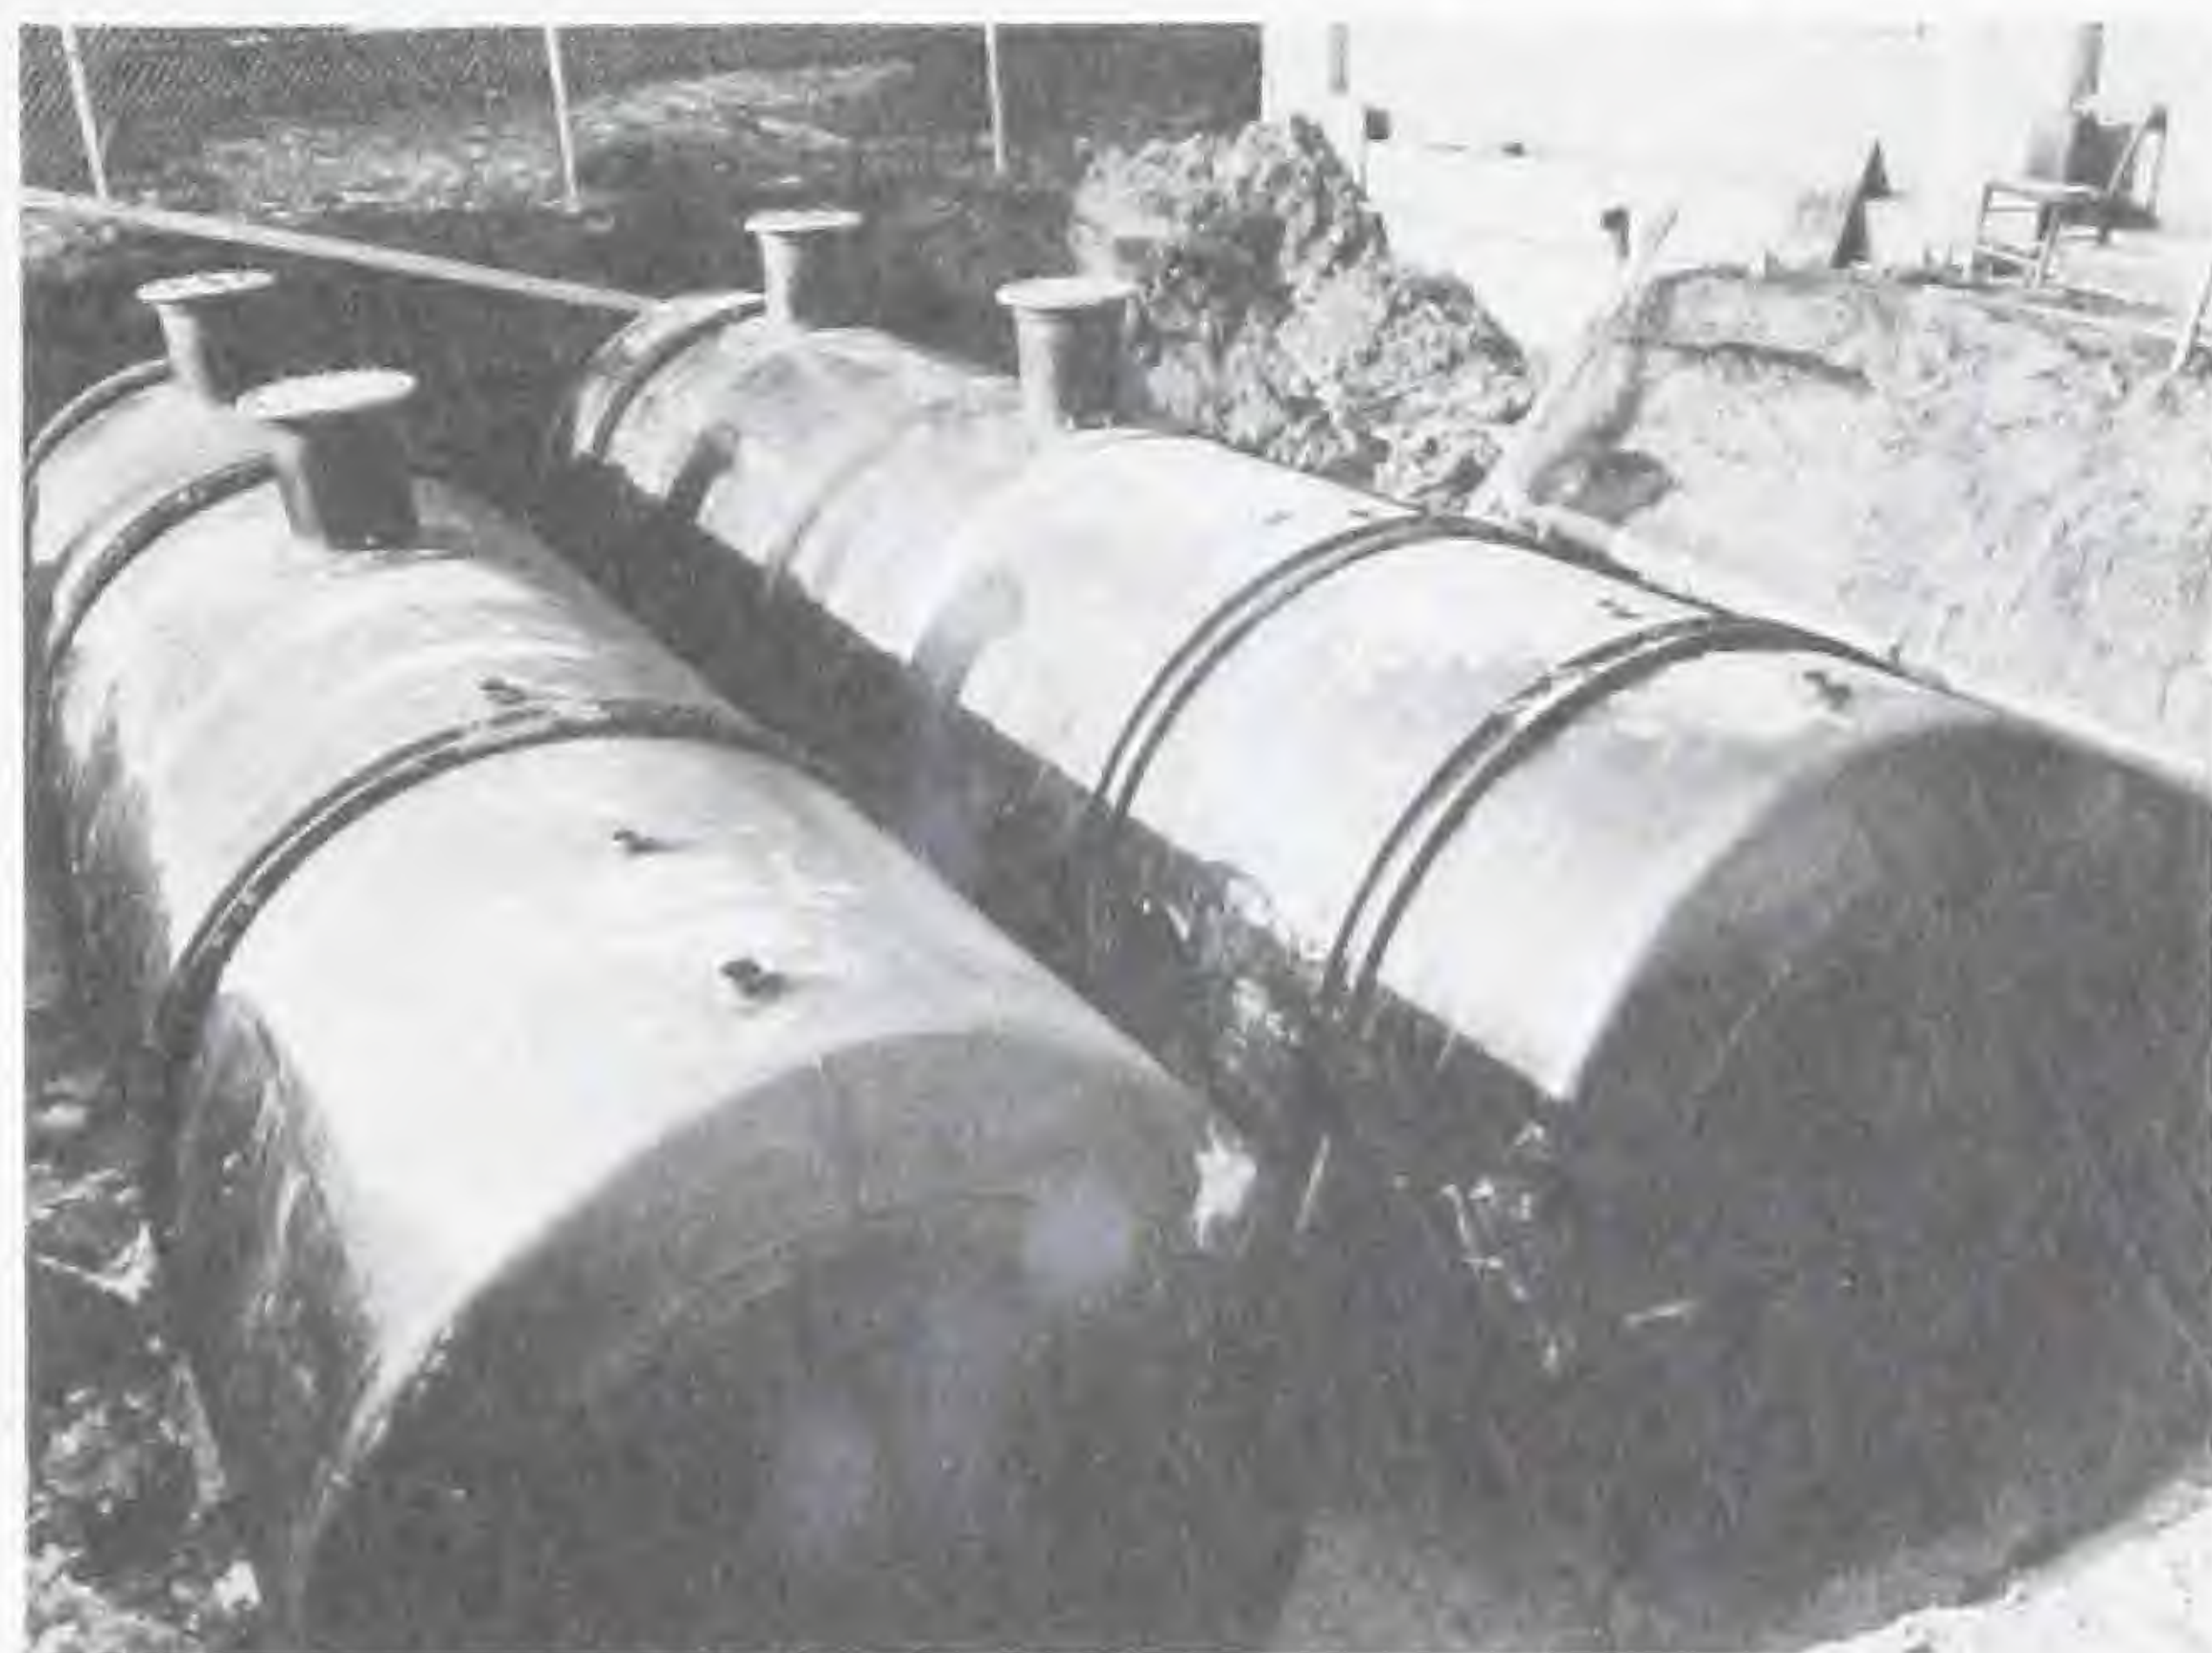
recently installed. They are shown in Fig. 41 and were fabricated from  $\frac{3}{8}$ " genuine wrought iron plates by Oldman Boiler Works, Inc., in Buffalo. The method of fabrication of the heads can be seen in Fig. 42.

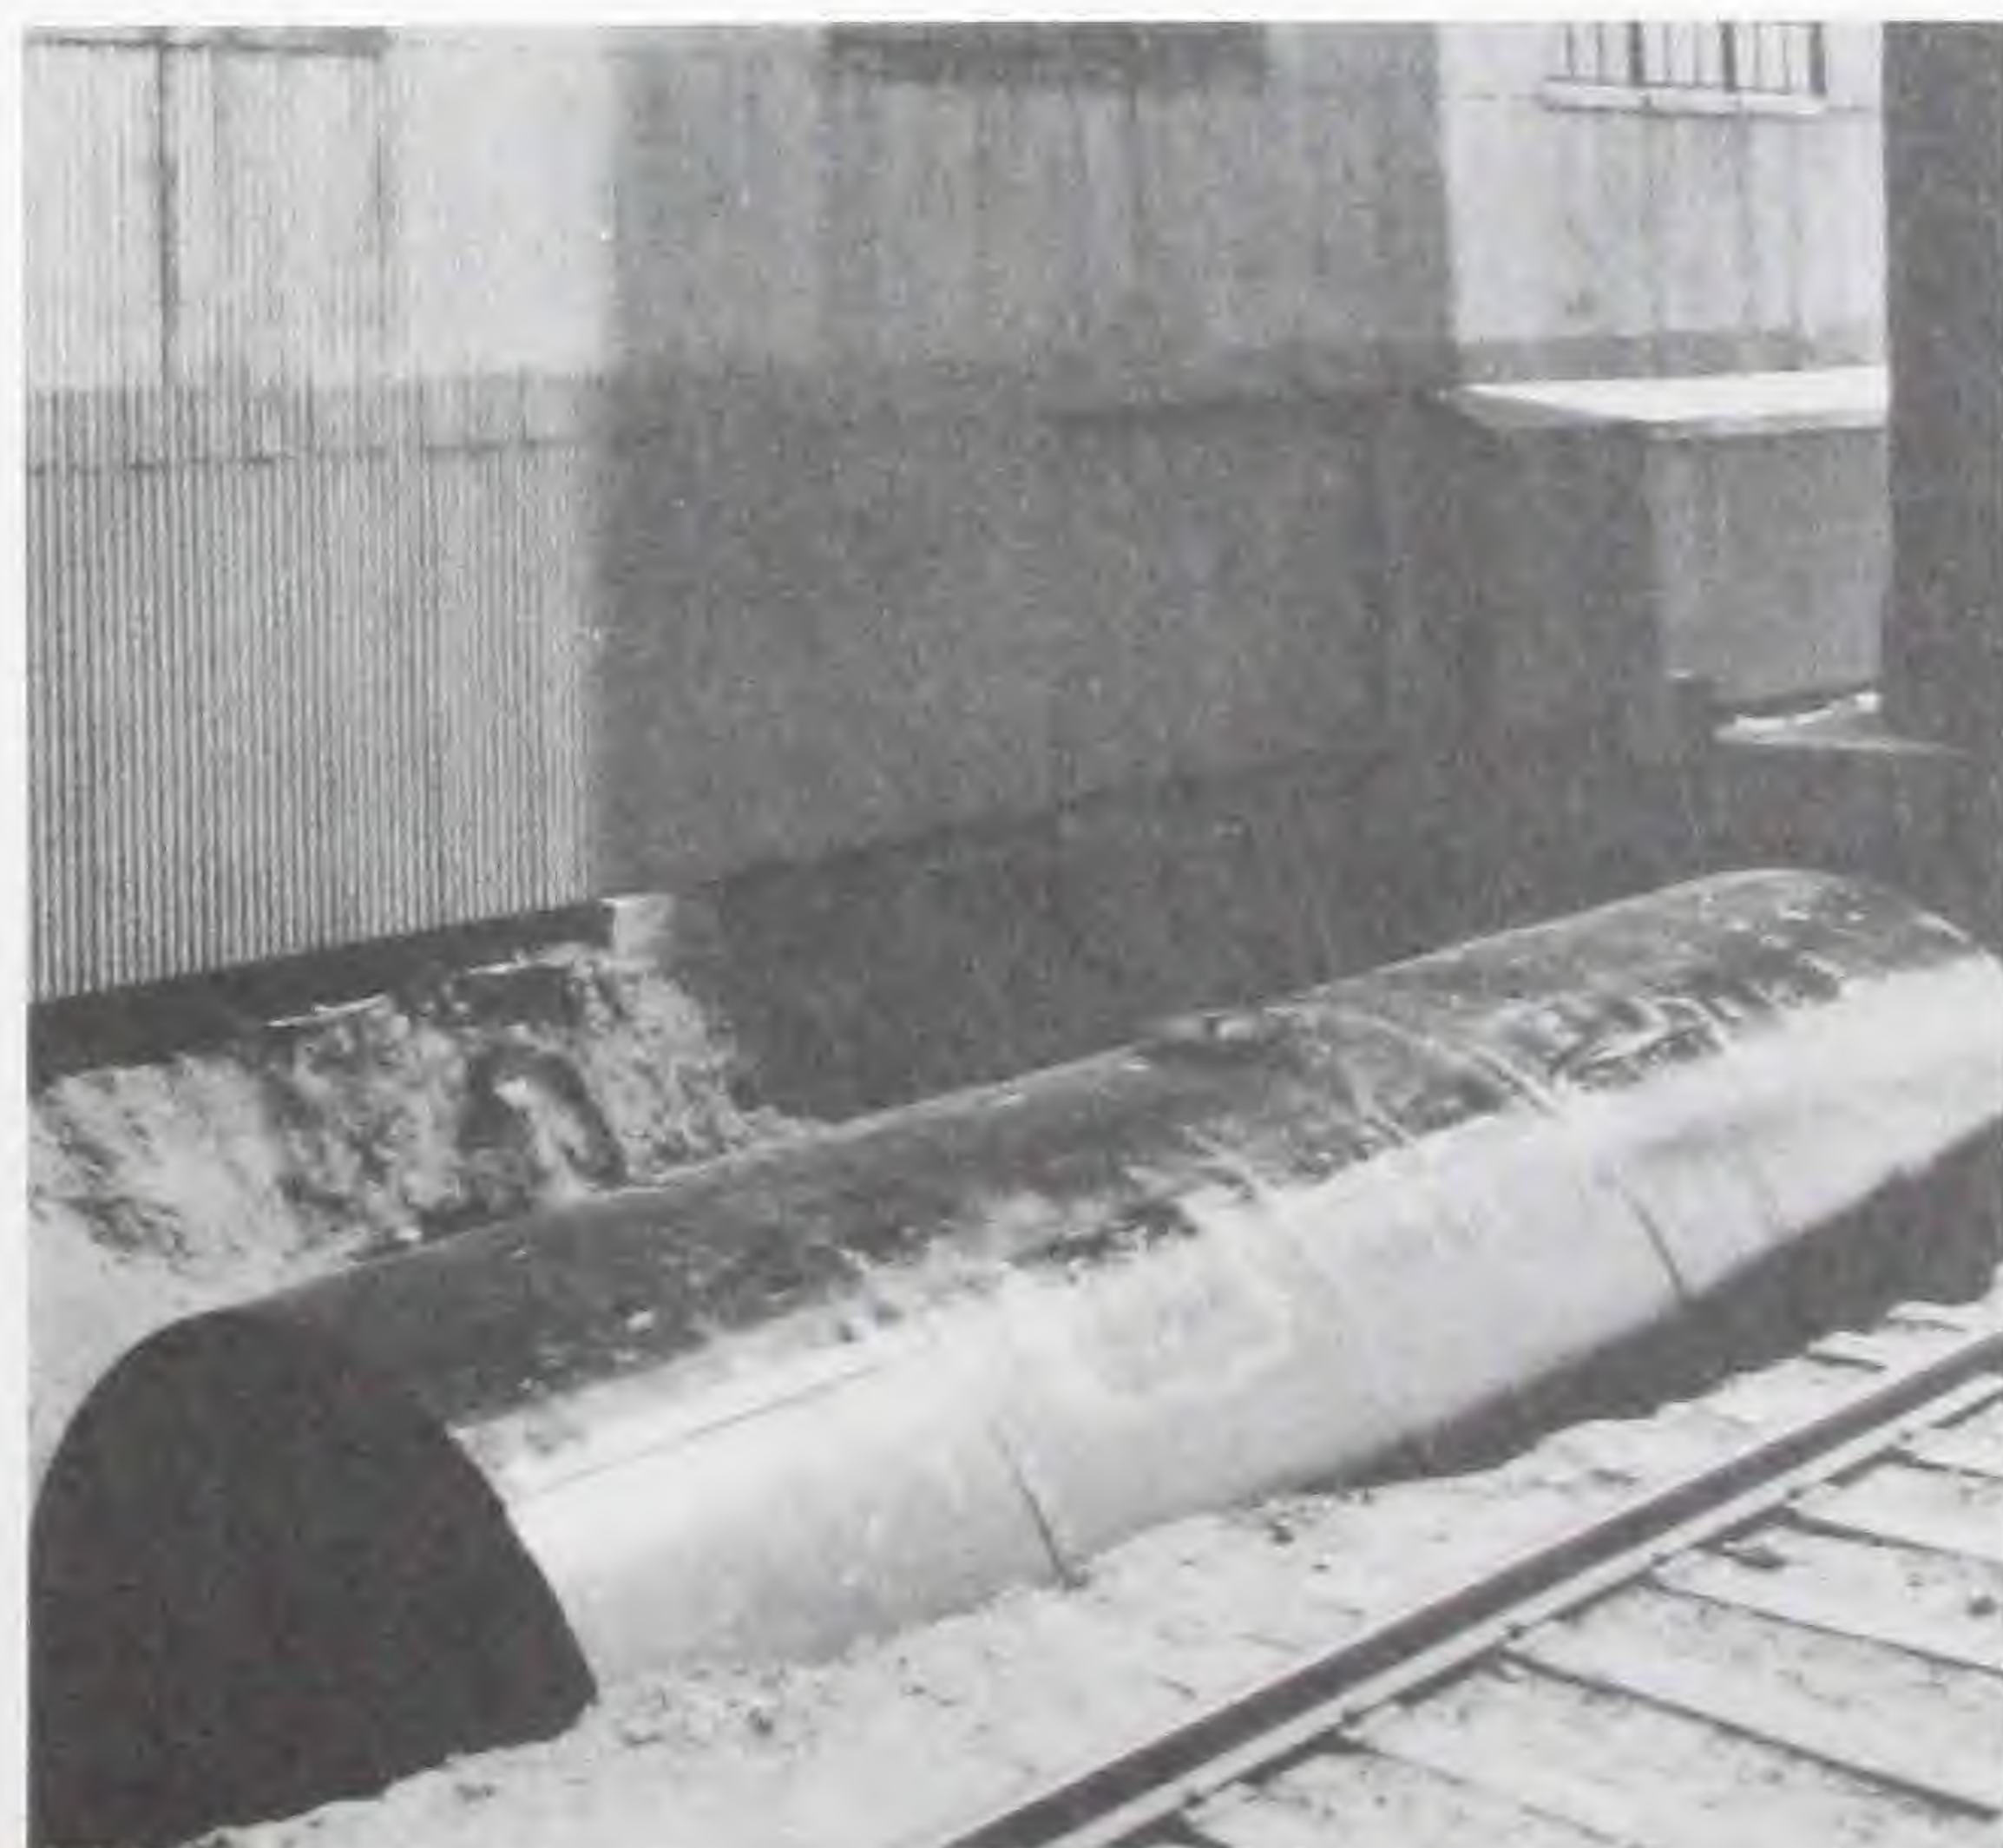
Fig. 43 shows a 25,000 gallon genuine wrought iron tank, used to store number six grade fuel oil, or Bunker "C" fuel oil, at a large industrial plant. As can be seen by the proximity of the railroad track, vibration, as well as corrosion, undoubtedly contributes to the severity of the operating conditions.
